2183 USPS Processing & Distribution Ctr REPORT
Multnomah
Final Closure Report April 12, 2012

Final Closure Report

**USPS Portland P&DC
715 Northwest Hoyt Street
Portland, OR 97208**

April 2012

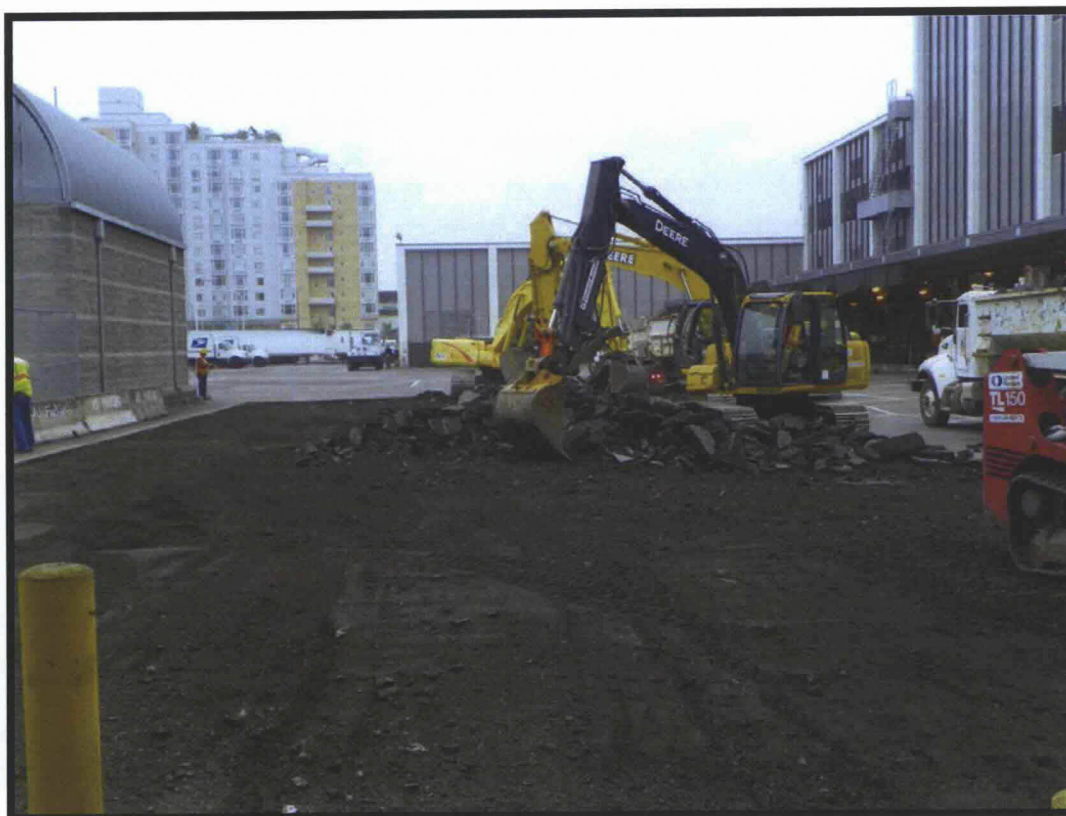
Loading removed pavement in Utility Vault Area.

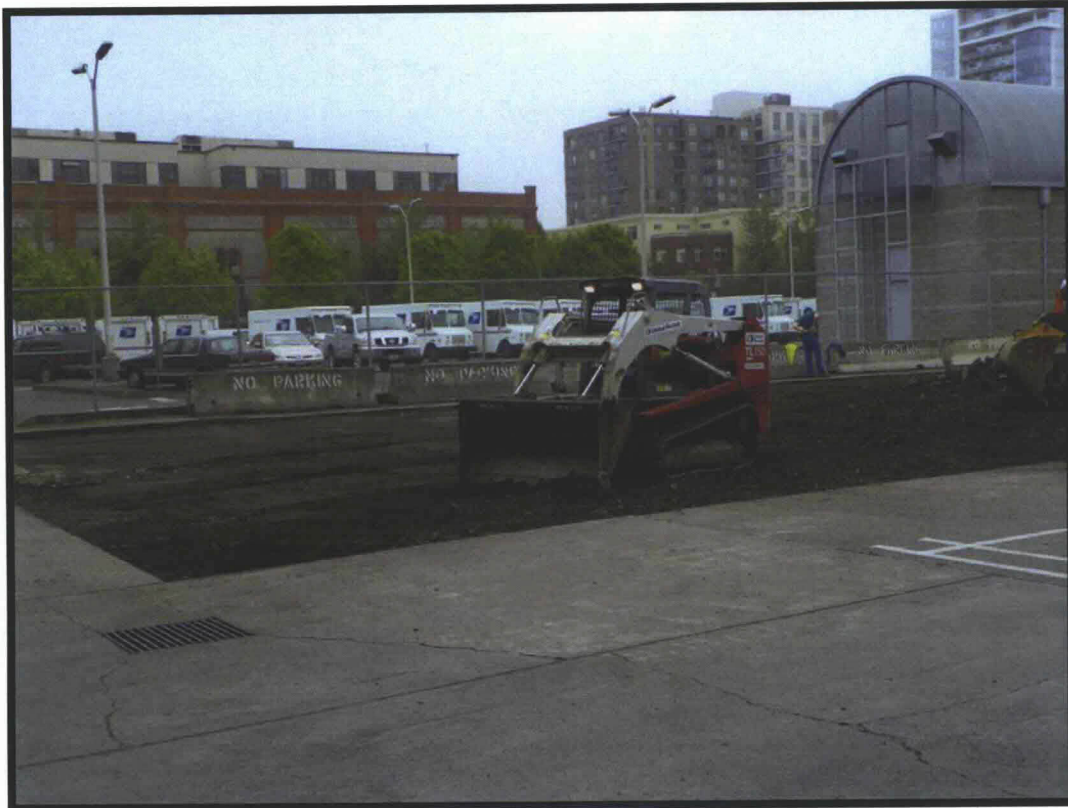
Grading in Utility Vault Area.

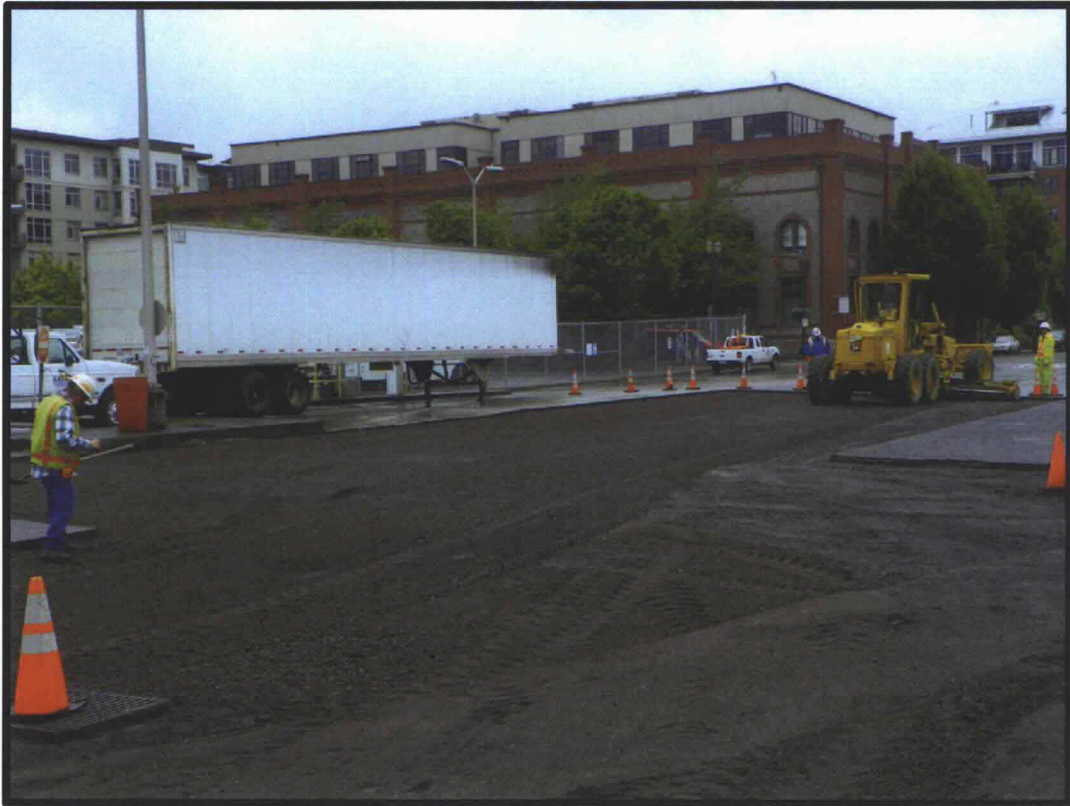
Grading at site entrance in former Coach Cleaning Area.

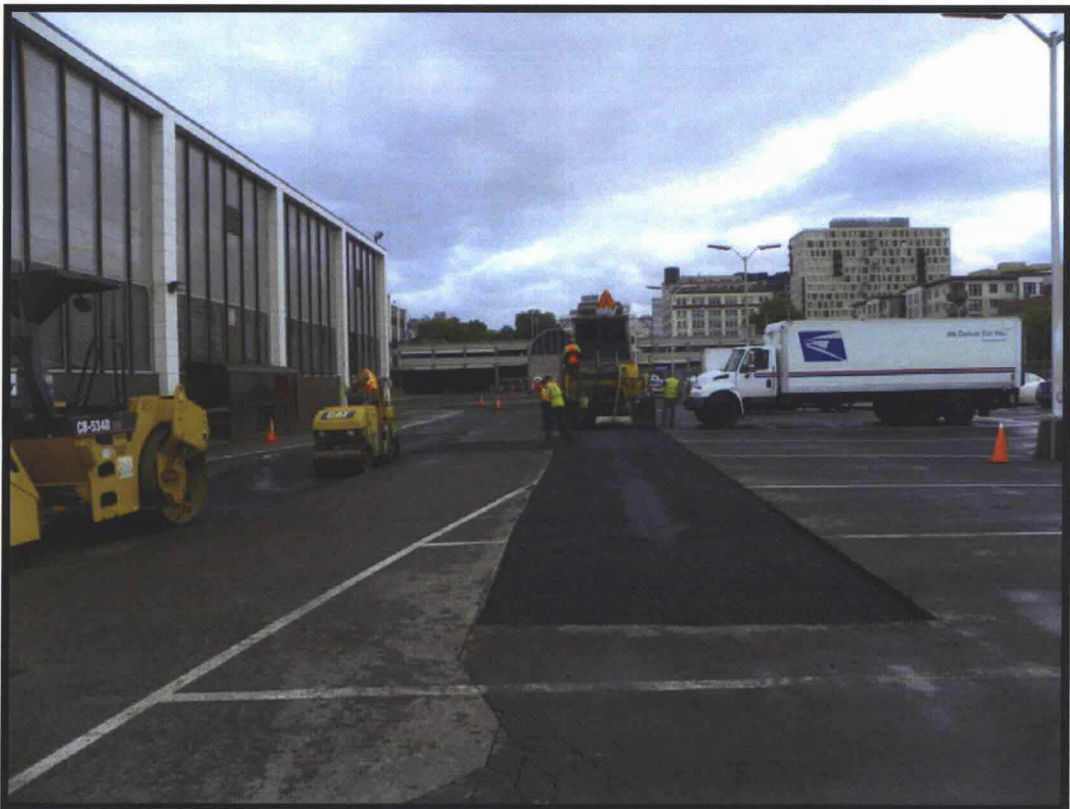
Paving placement and rolling/compacting in drive aisle along west side of P&DC Building.

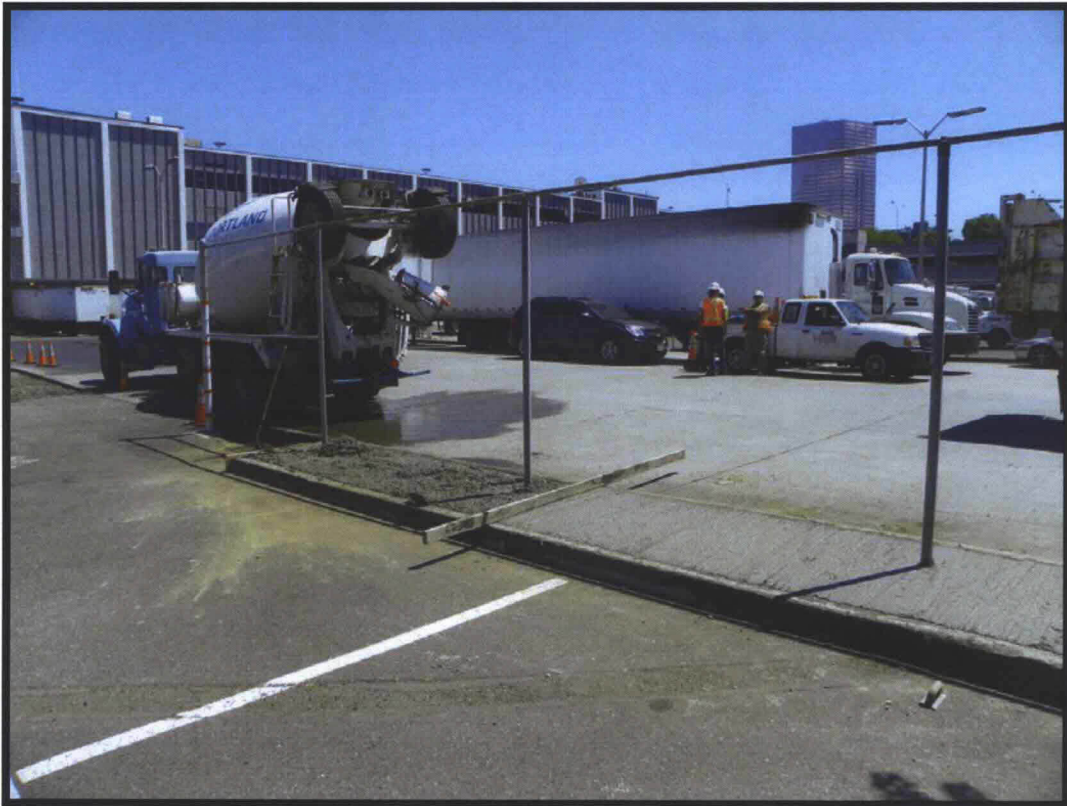
Concrete placement in former landscaped area near site entrance.

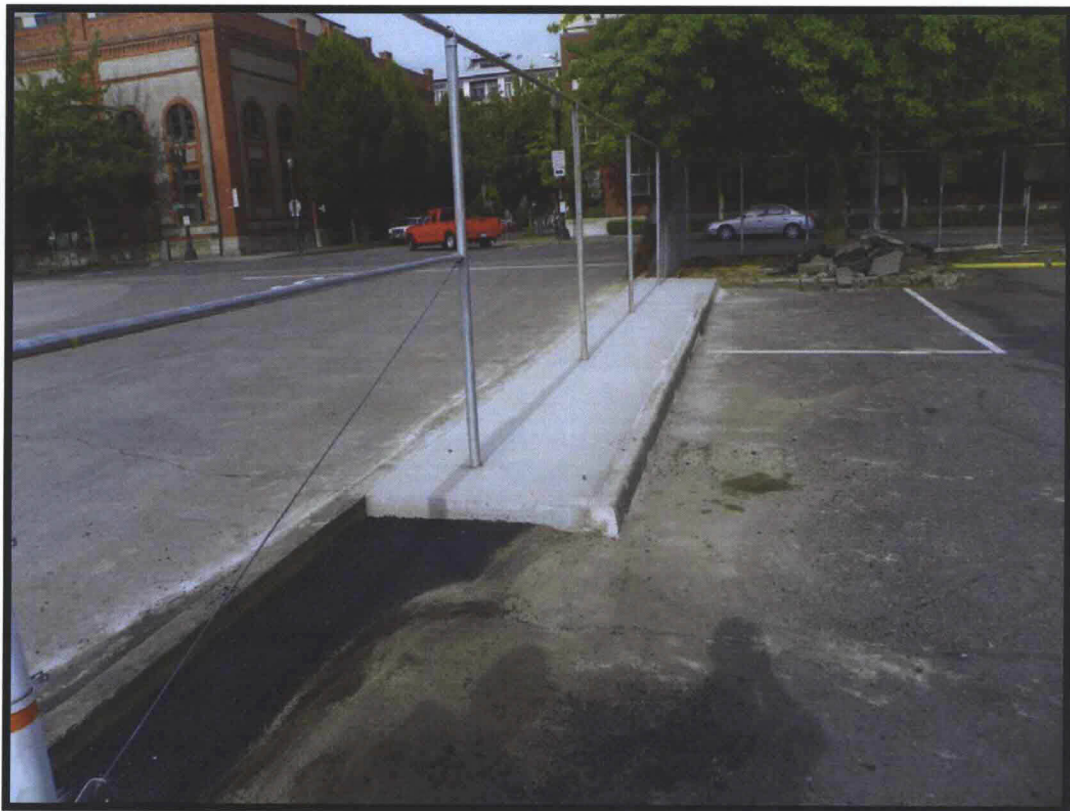
Finished concrete and asphalt pavement in former landscaped area near site entrance.

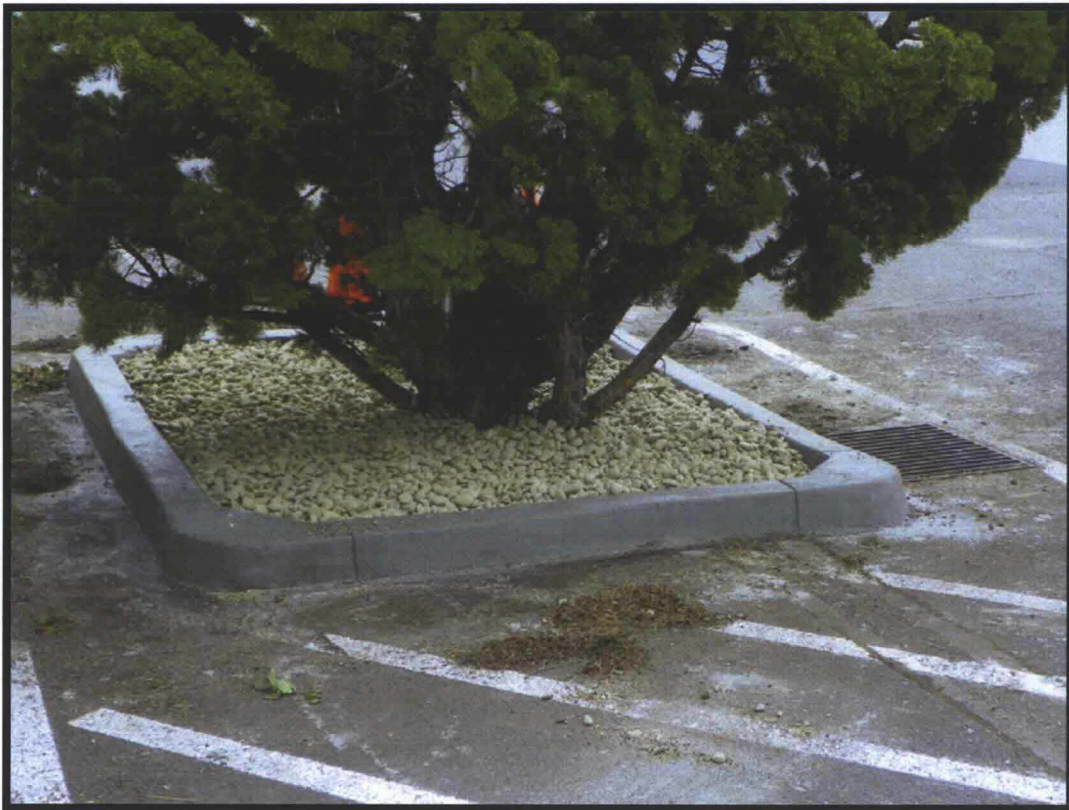
Finished landscaped area (shrub) along north side of site entrance.

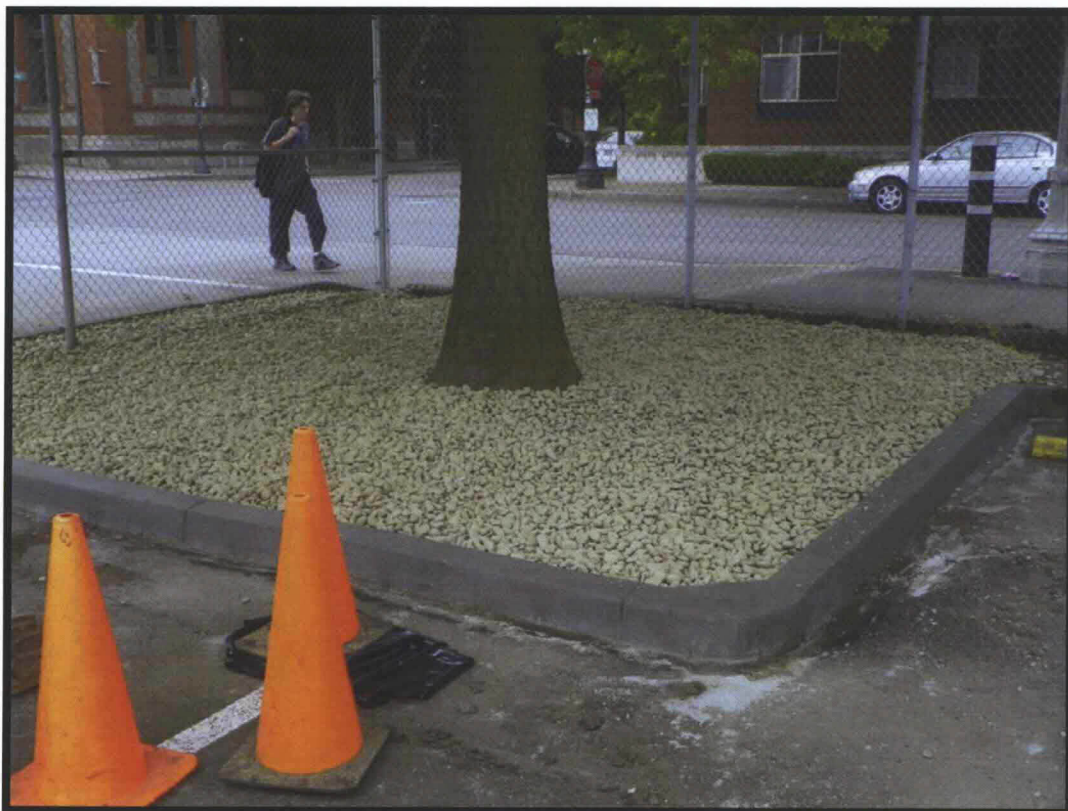
Finished landscaped area (tree) along north side of site entrance.

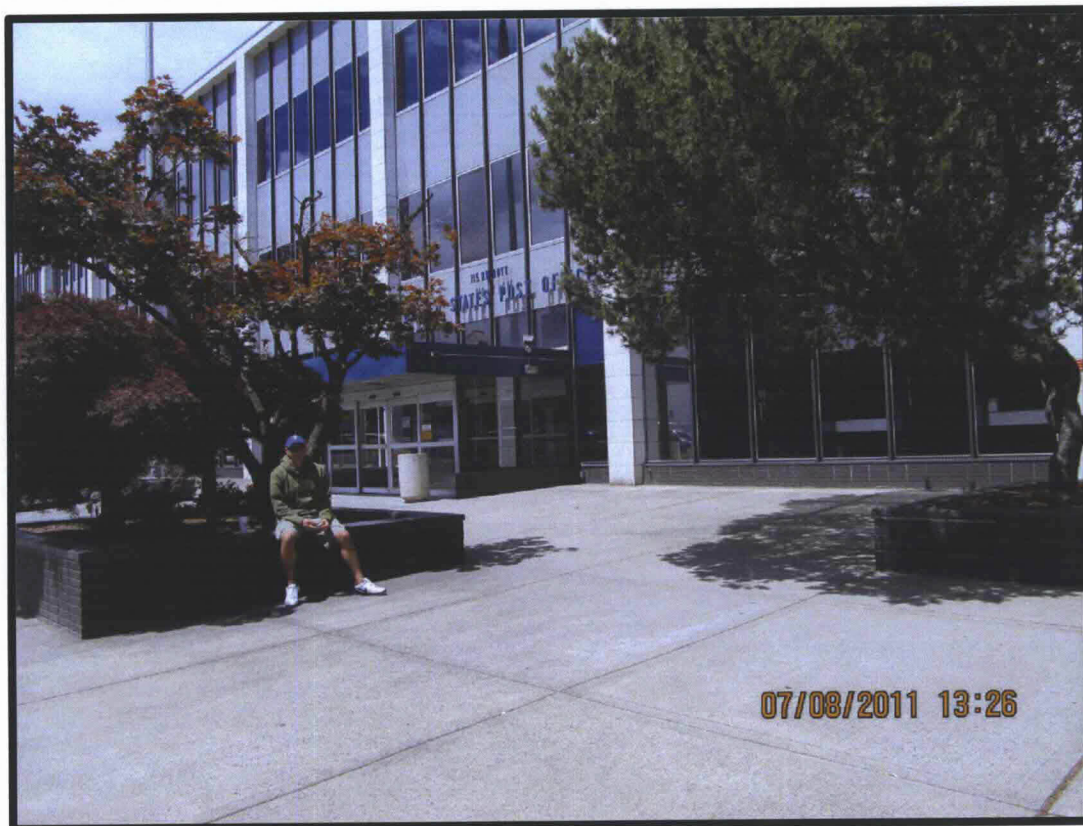
Photo 2 - Looking northwesterly at landscaped areas located along NW Hoyt Street (southeast corner of Site).

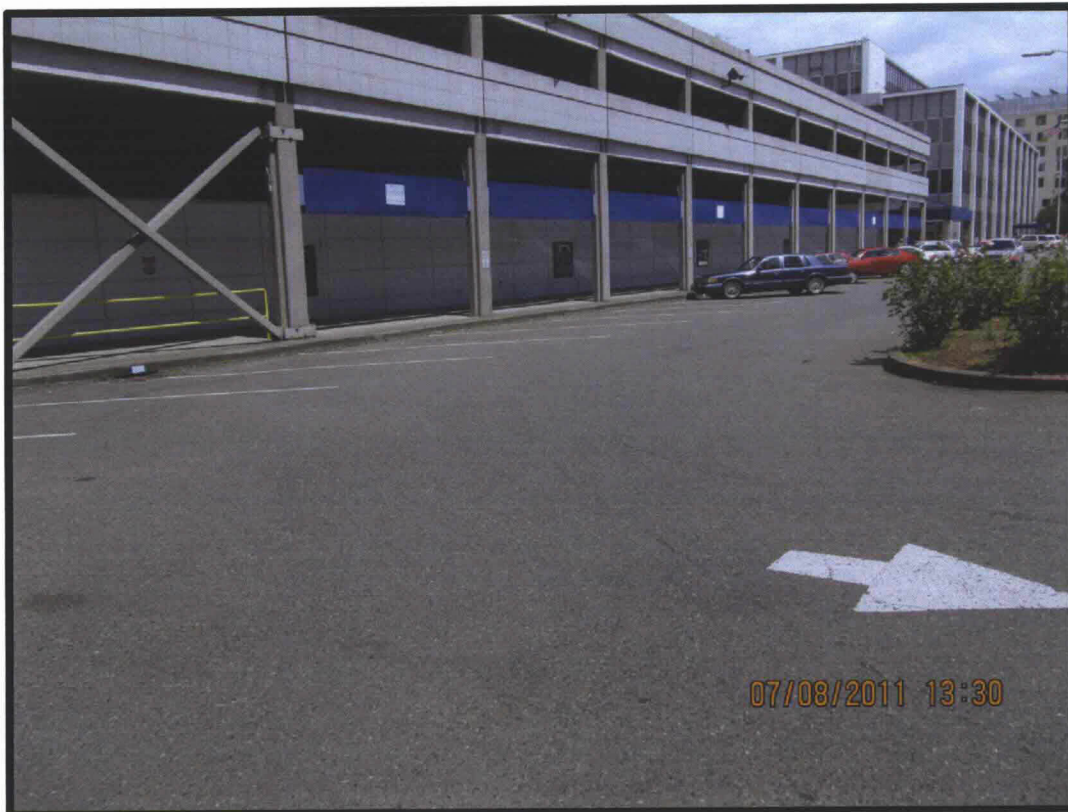
Photo 4 - Looking easterly at drive lane, landscaped area (right side of photo) and public parking area located along NW Hoyt Street (south side of Site).

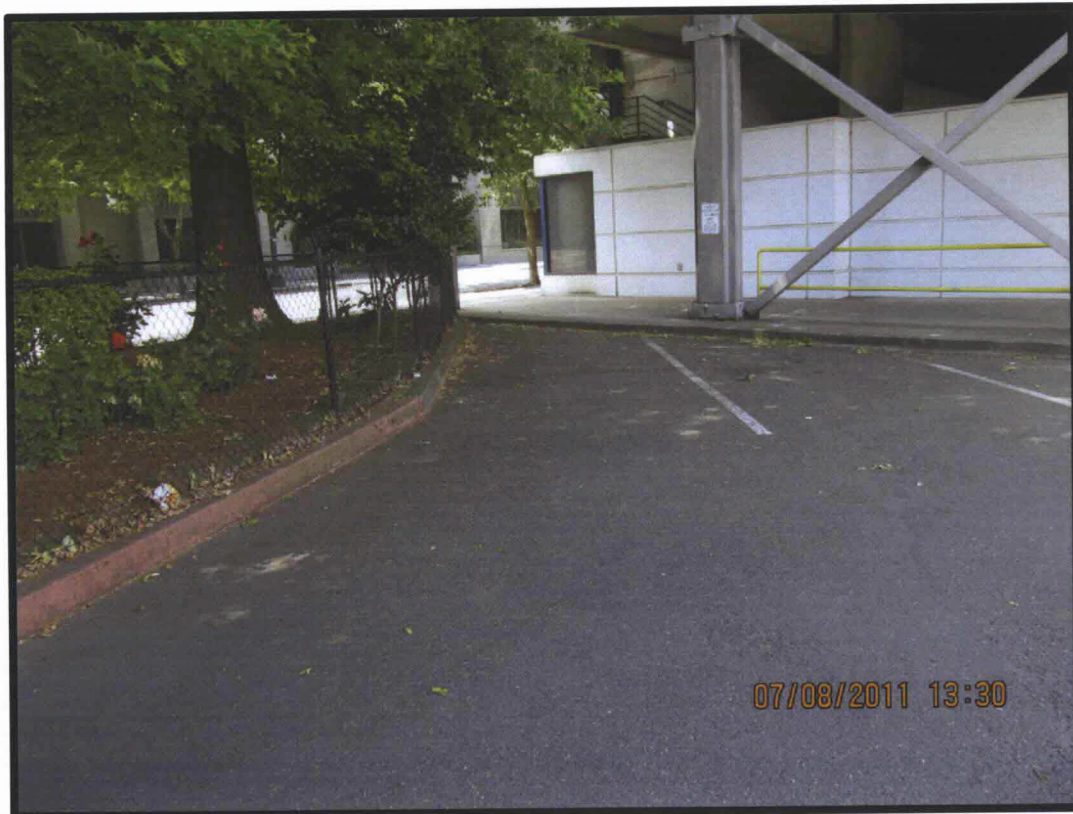
Photo 5 - Looking northerly at public parking area (right side of photo) and landscaped area (left side of photo) located along NW Hoyt Street (south side of Site).

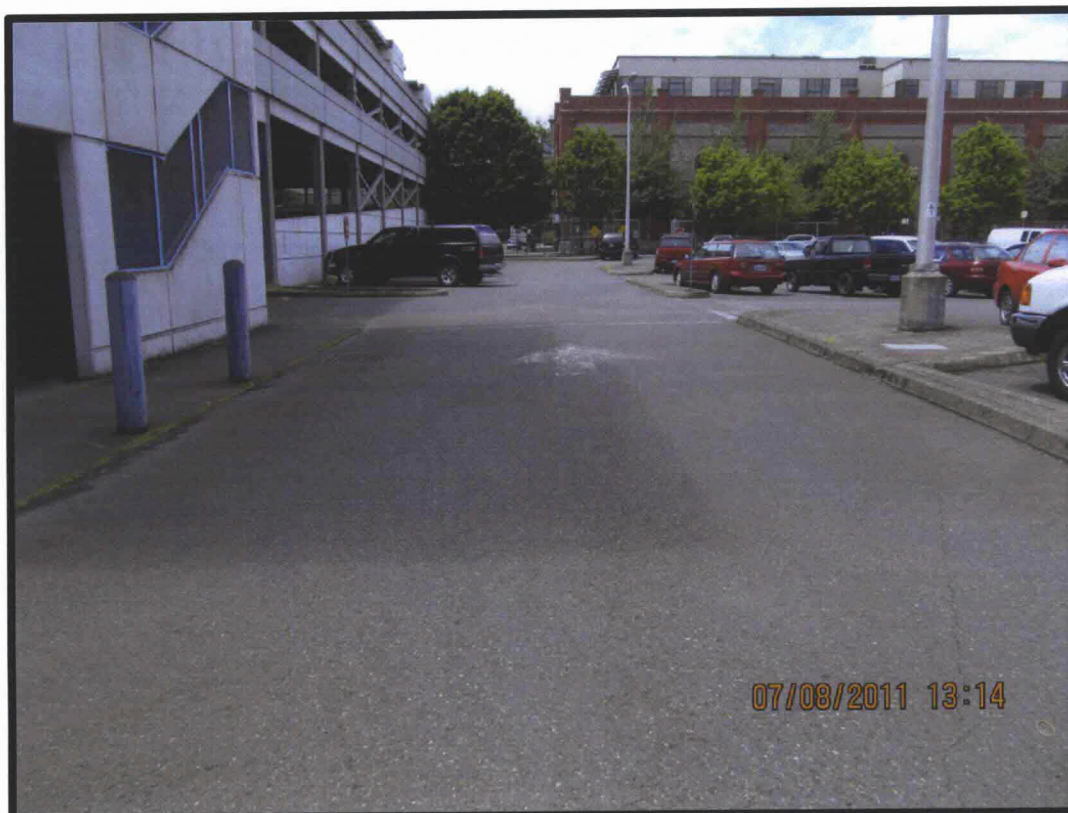
Photo 8 - Looking westerly at drive lane for employee parking lot.

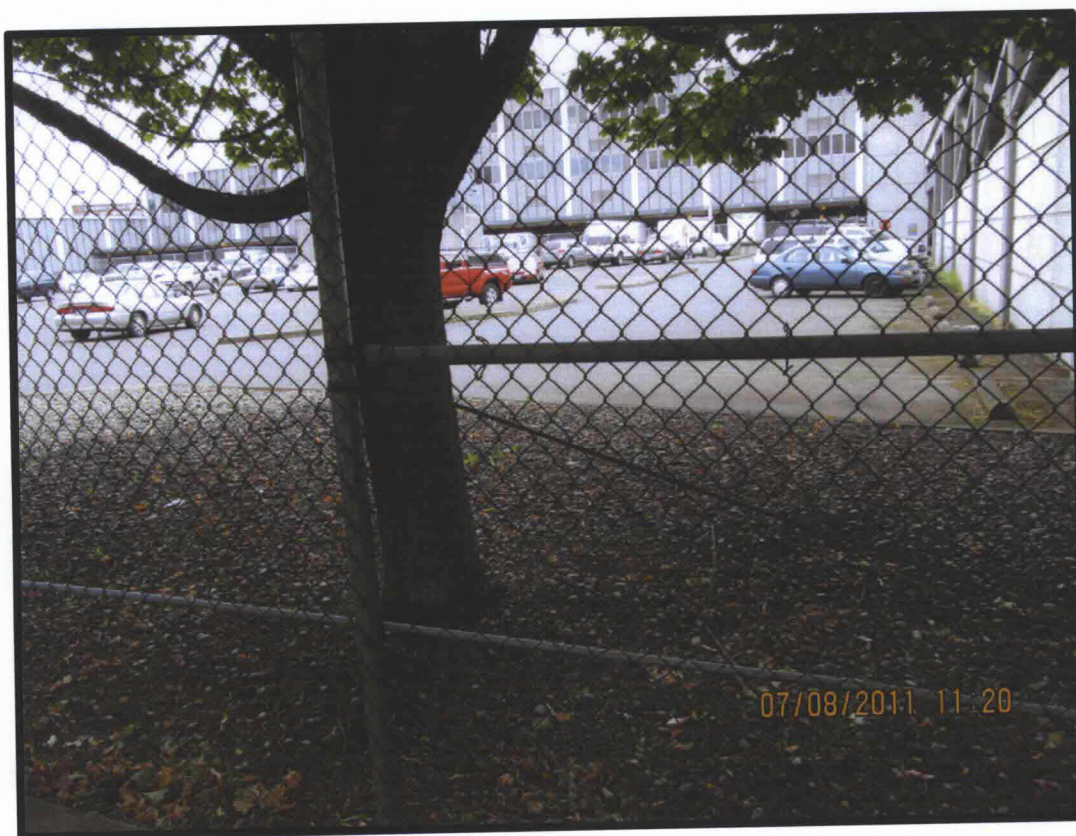
Photo 10 - Looking easterly at landscaping located along western property line, adjacent to employee parking lot (near northwest corner of employee parking garage).

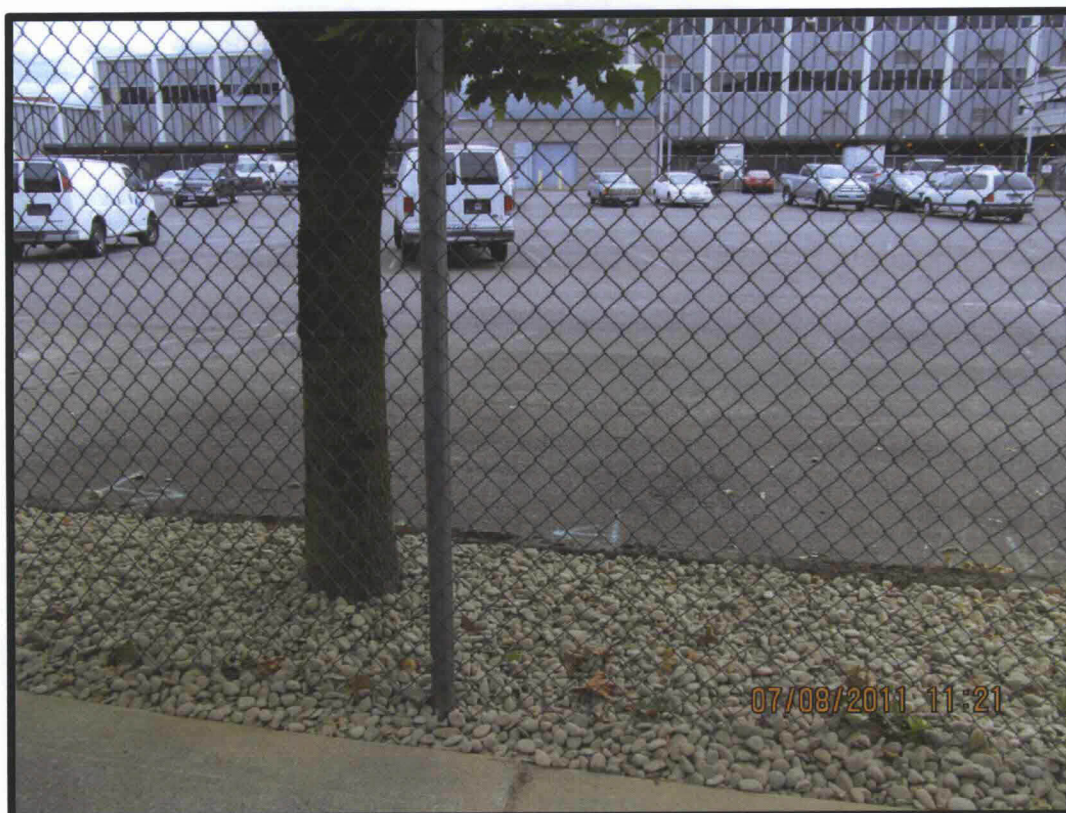
Photo 11 - Looking easterly at landscaping located along western property line, adjacent to employee parking lot.

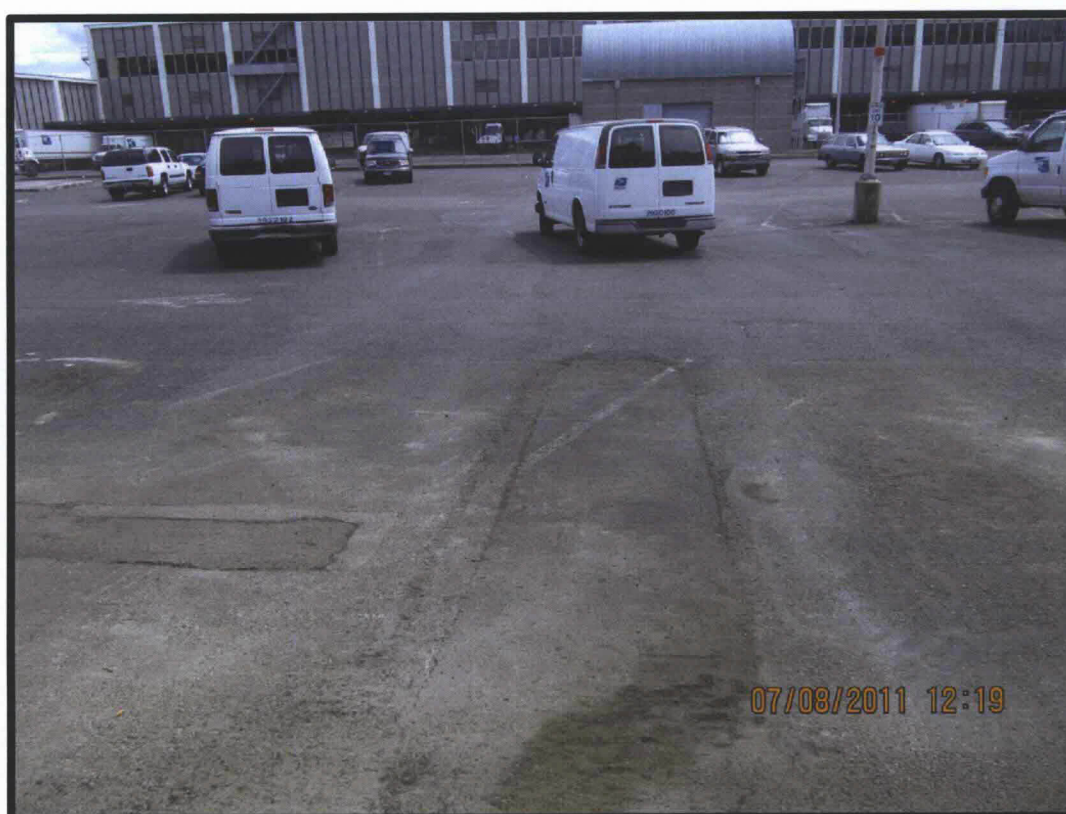
Photo 12 - Looking easterly at employee parking lot.

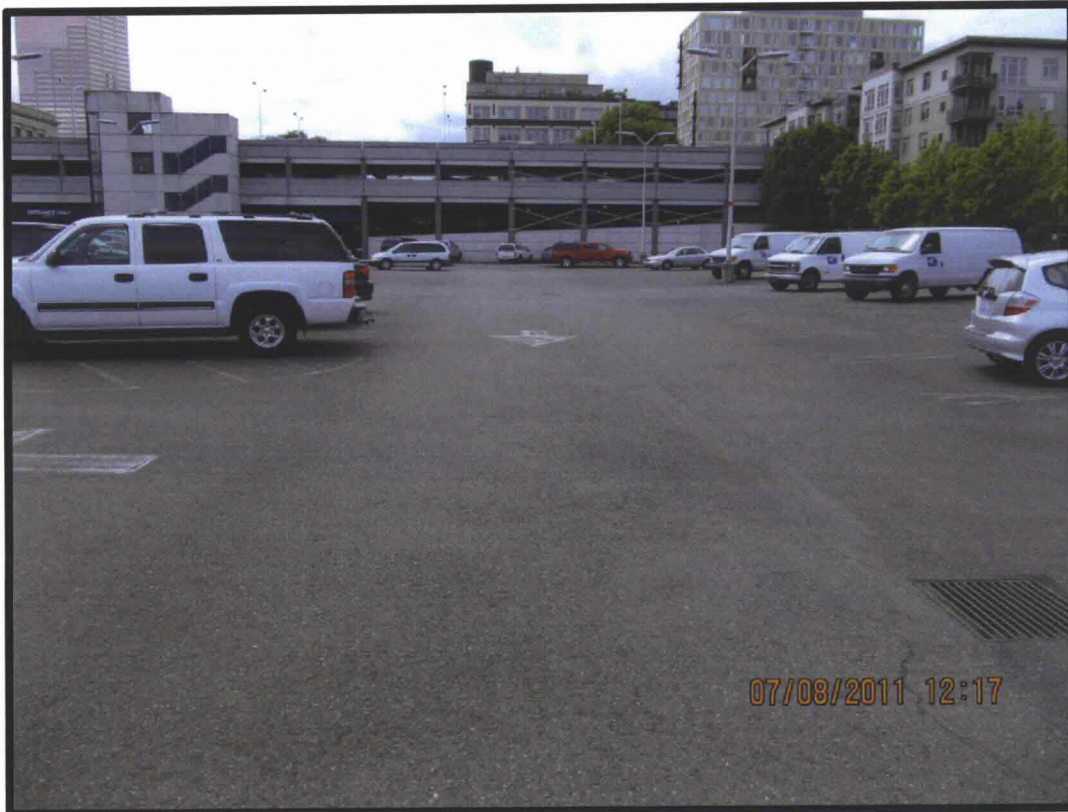
Photo 14 - Looking southerly at center drive lane of employee parking lot.

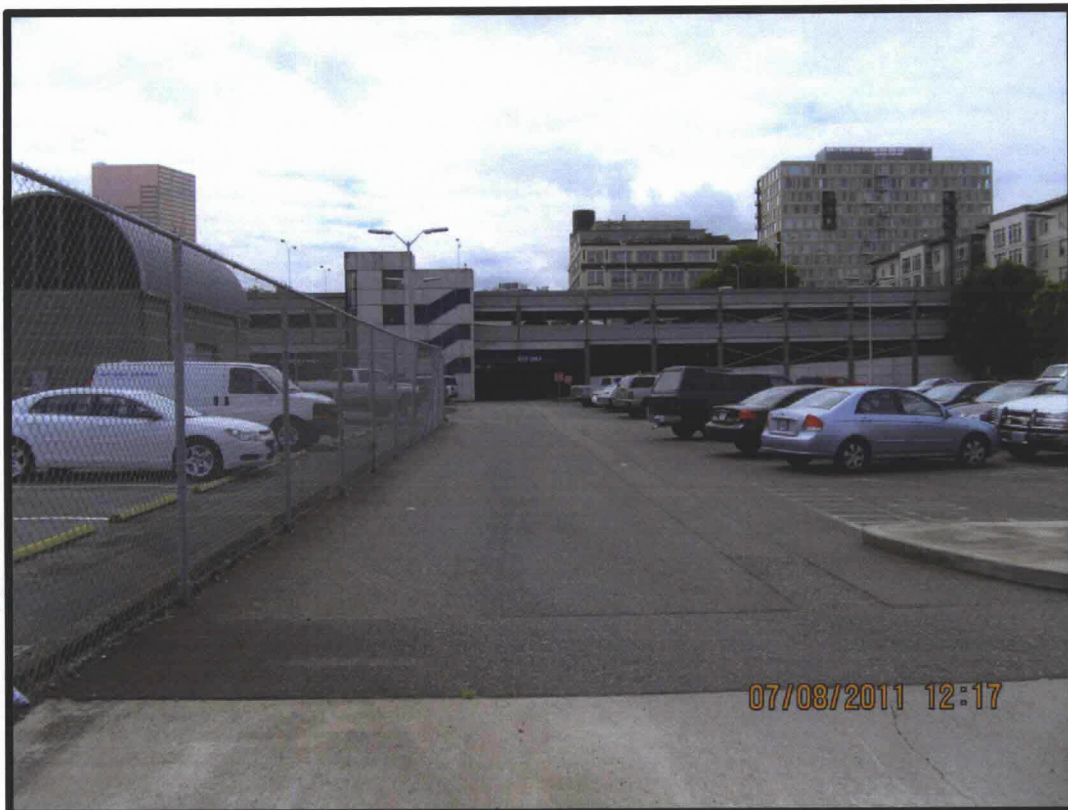
Photo 15 - Looking southerly at entrance/east drive lane into employee parking lot.

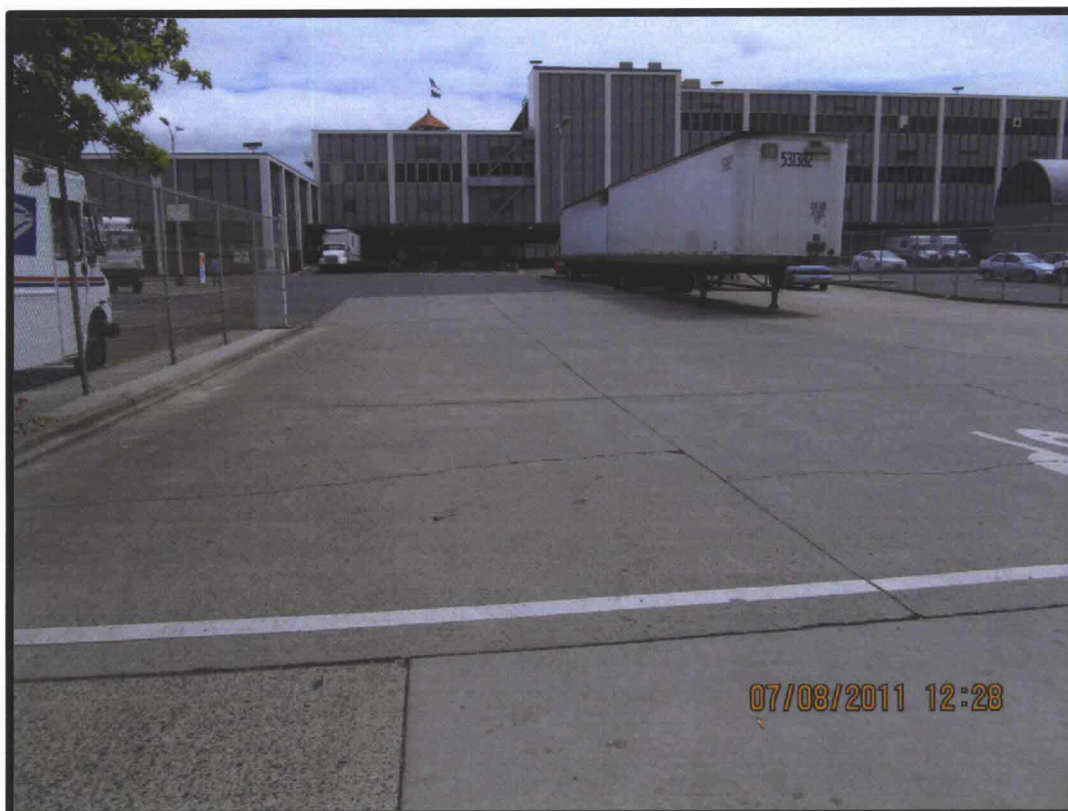
Photo 16 - Looking easterly at main entrance/drive lane into Site off NW 9th Ave.

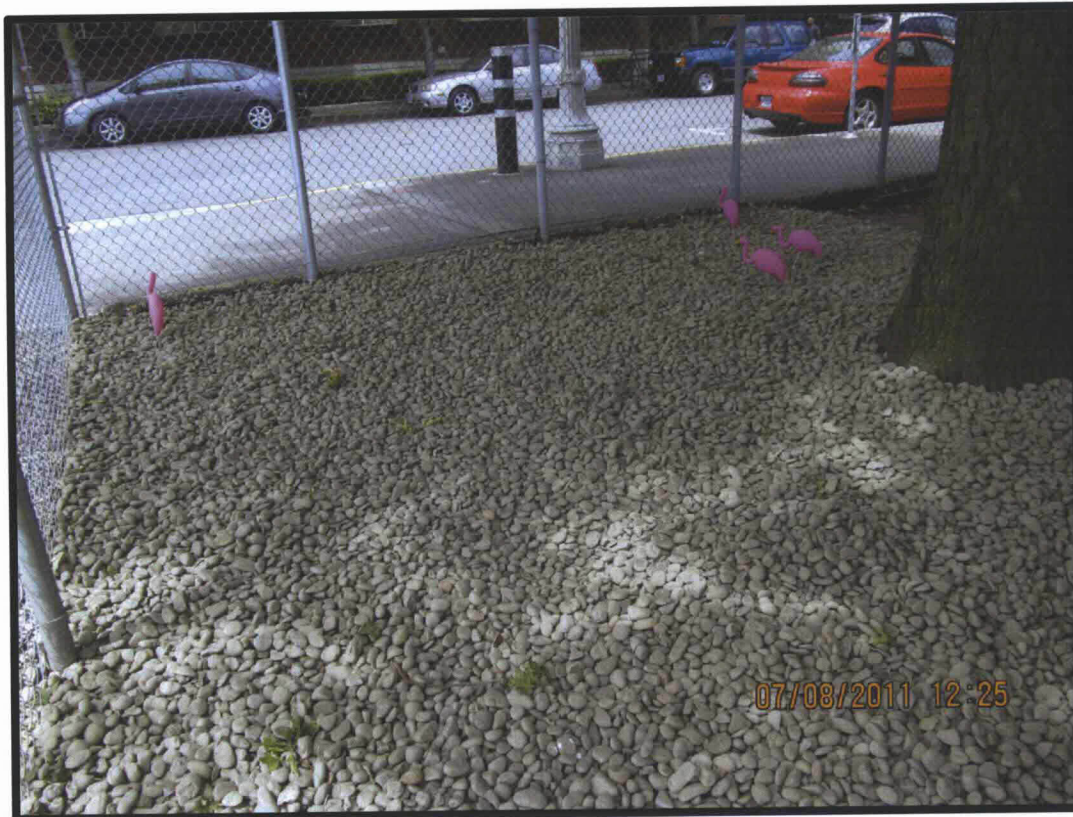
Photo 17 - Looking westerly at landscaped area adjacent to the main entrance into Site off NW 9th Ave.

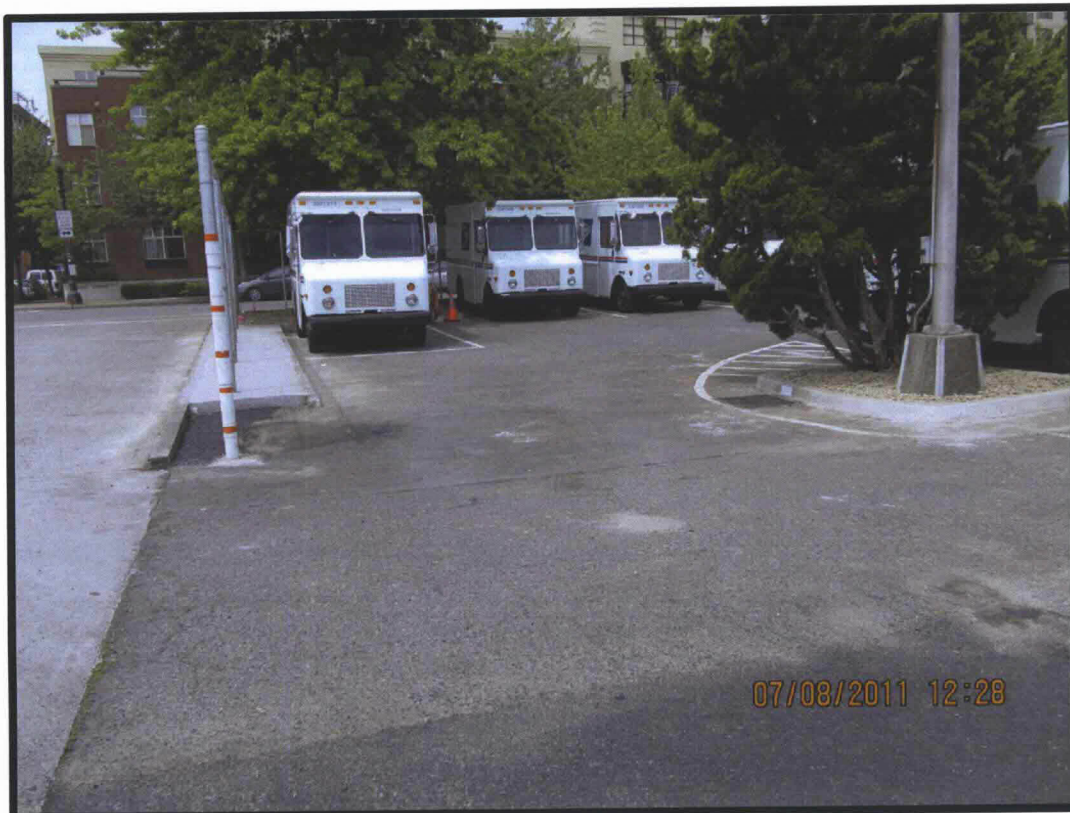
Photo 18 - Looking westerly at western area of truck parking lot. Small landscaped areas on right (north) and top (west) sides of photo.

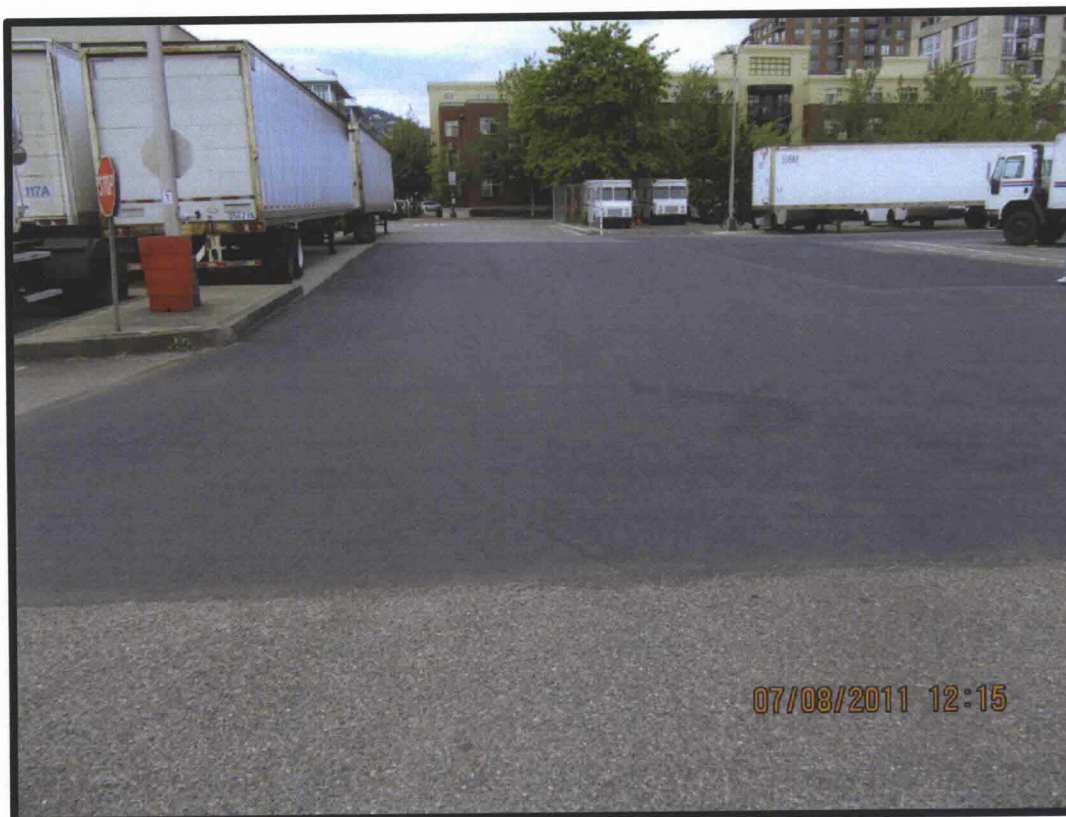
Photo 19 - Looking westerly at pavement repair at main entrance/drive lane into facility off NW 9th Ave.

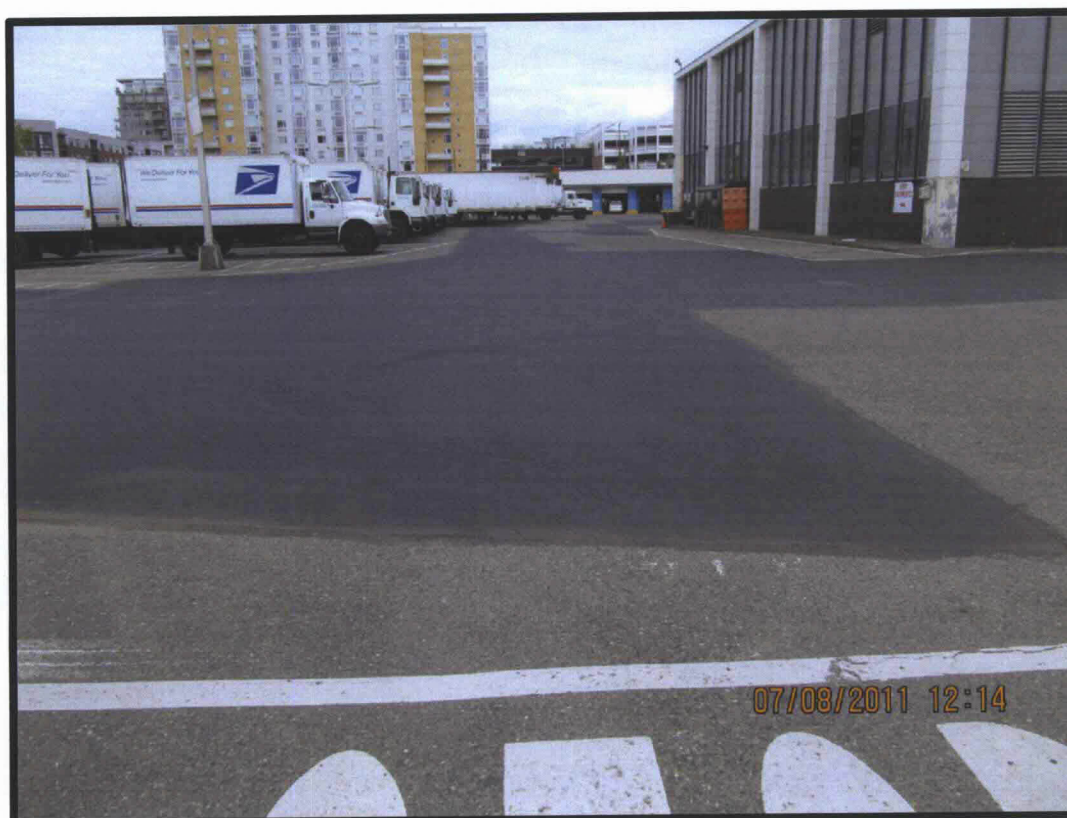
Photo 20 - Looking northerly at pavement repair and east drive lane to VMF and north truck dock area.

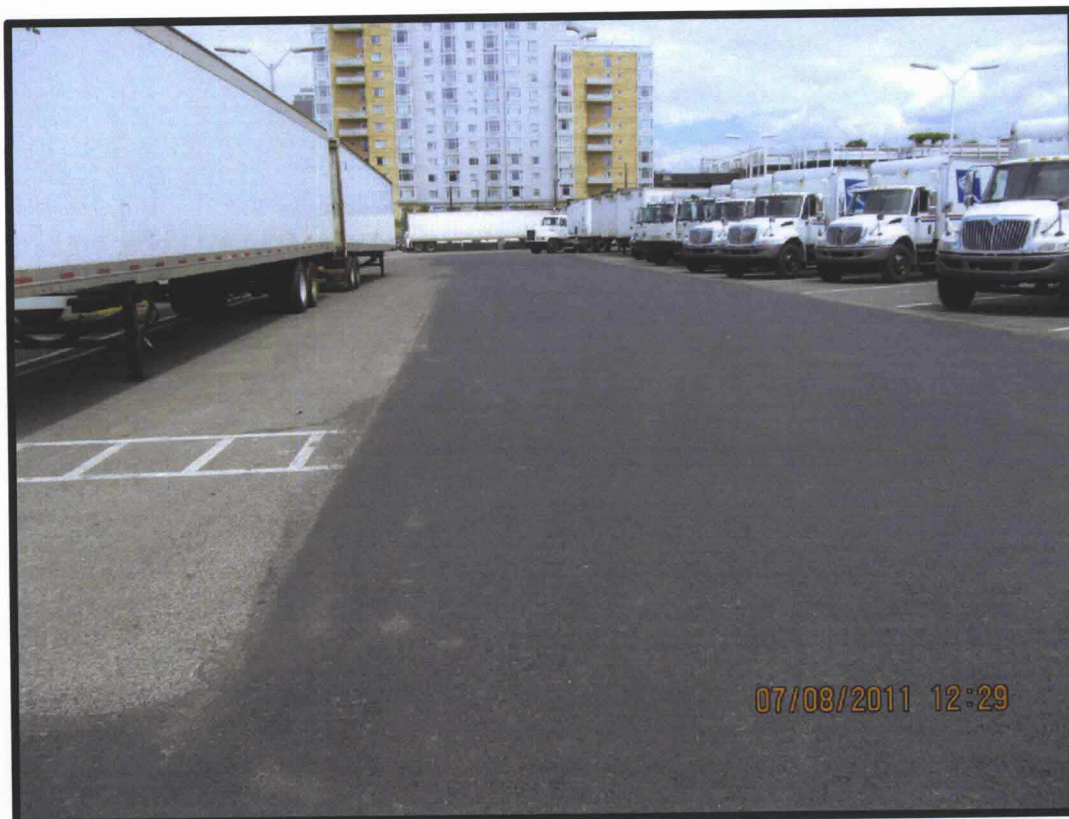
Photo 21 - Looking northerly at pavement repair in central area of western truck parking lot.

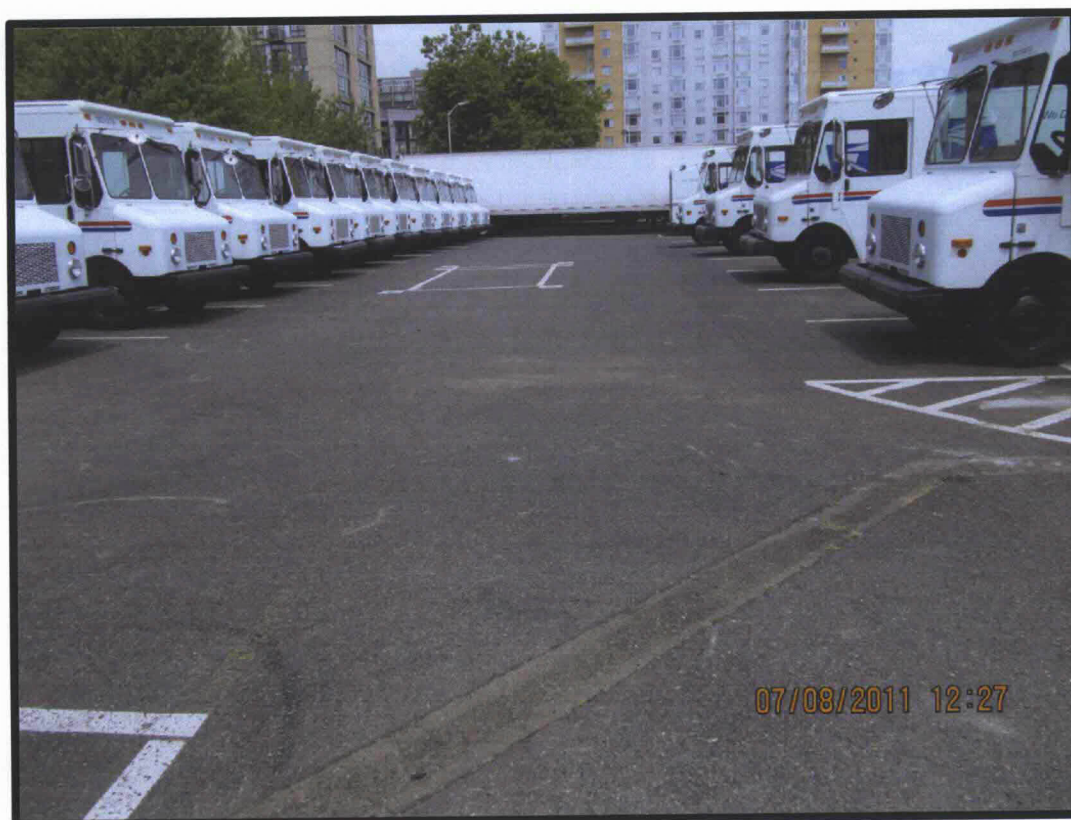
Photo 22 - Looking northerly at western area of truck parking lot.

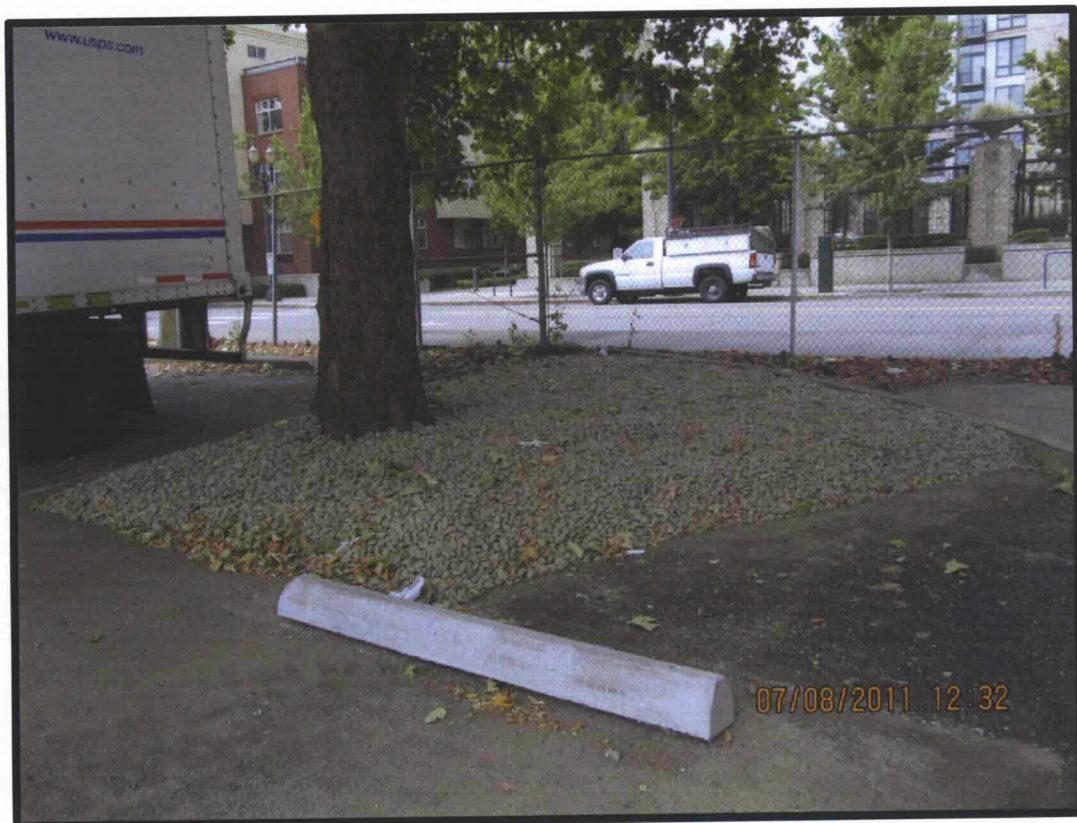
Photo 24 - Looking southwesterly at landscaping in northwestern area of truck parking lot.

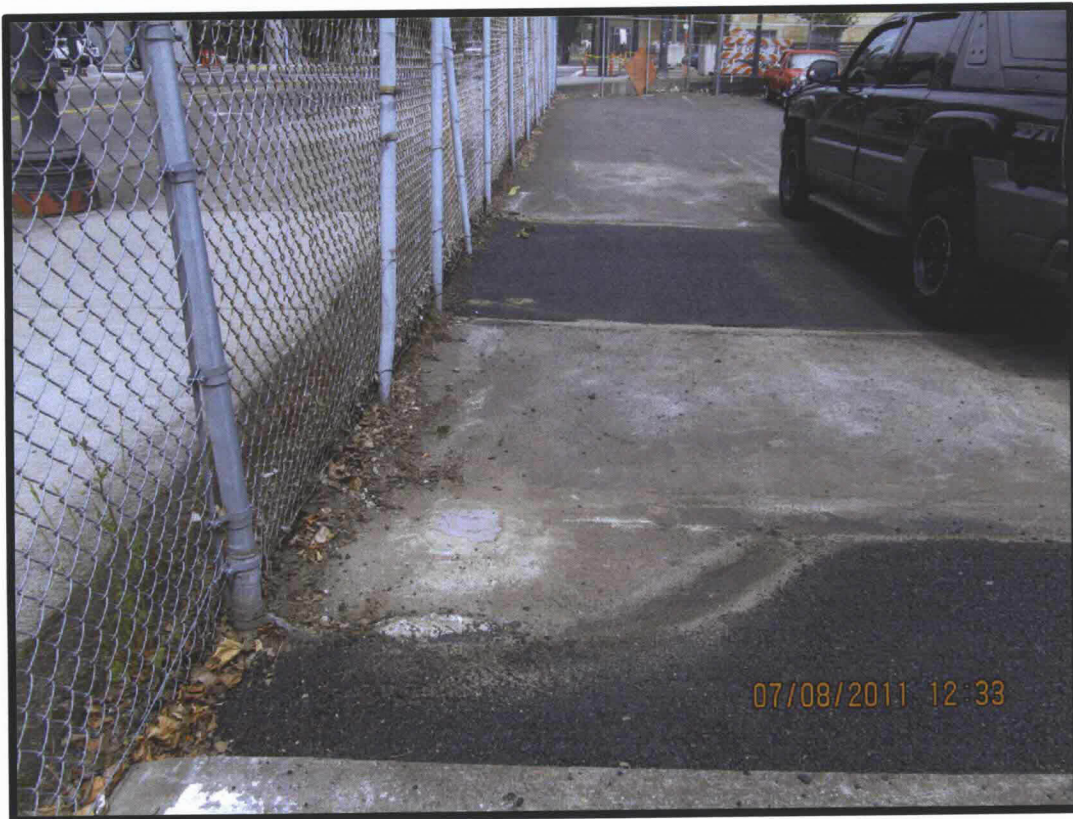
Photo 26 - Looking northerly along western property line, pavement repair in northwest corner of Site.
